SEMI AUX033-0617

450mm PIC Interoperability Report

International 450 mm PIC Task Force
PI&C Global Technical Committee

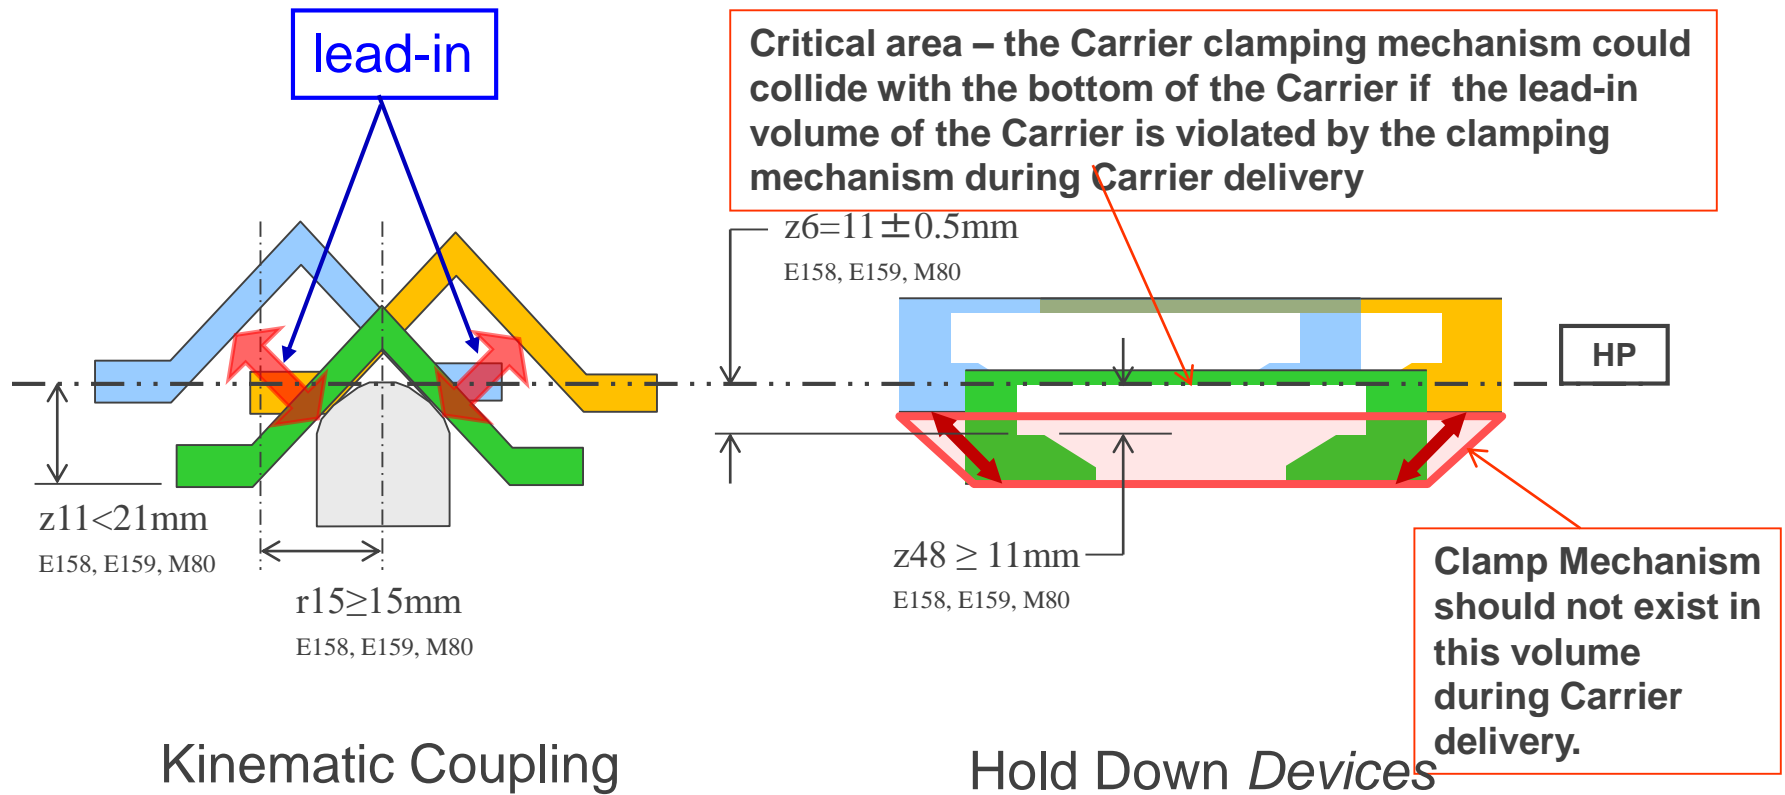
Load Port: Interference Between Load Port Features and Kinematic Coupling Lead-in Grooves at the time of Carrier Delivery

Load Port: Interference Between *Hold-down Devices* and Kinematic Coupling Lead-in Grooves at the time of Carrier Delivery

- Requirement:
 - In order to avoid interference between Carrier and LP features except KC-pins, lead-in function should be considered.
- Related Standards:
 - E154, E158, E159 and M80
- Impact to Standards:
 - No change
- Application Note:
 - None.
- Background:
 - Features that extend above the imaginary plane created by the three kinematic pins have been found to compromise the function of the 10 mm lead-in provided by the kinematic coupling.
 - Critical area – the Carrier clamping mechanism must not collide with the bottom of the Carrier
- Approach:
 - Ensure that no equipment features compromise the lead-in function provided by the kinematic coupling mechanisms.
- Note:
 - The following page presents the interference issue described herein. ¹¹

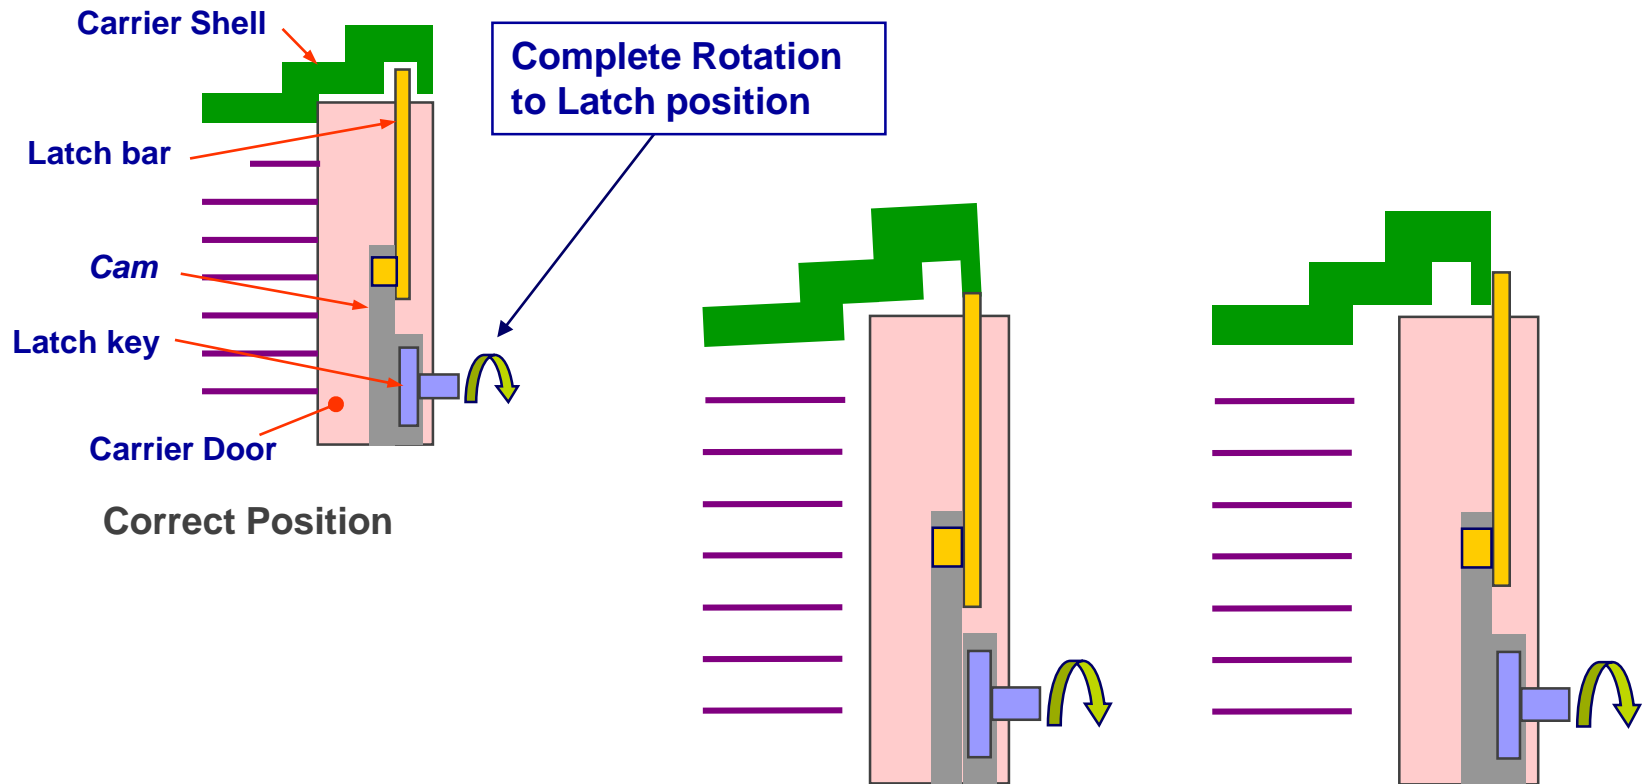
- Possible to detect latch key rotation only

Typical incorrect case (not latched into Carrier)

- Requirement:
 - To prevent Carrier door drop during Carrier transfer by AMHS, for secure FAB operation.
- Related Standards:
 - E154, E158, E159 and M80
- Impact to Standards:
 - No change
- Application Note:
 - None.
- Background:
 - Detection of latch-key rotational position is not enough to confirm proper Carrier door close.
- Approach:
 - Load port to confirm proper Carrier door close by at least following 2 steps.
 1. Locate and confirm the Carrier door to designed position.
 2. Rotate and confirm latch keys to designed position.
- Note:
 - Even with above 2 steps approach, complete confirmation of door close can not be realized, because latch bar insertion into Carrier shell can not be directly detected with current latch system.

- Requirement:
 - To prevent Carrier door drop during Carrier transfer by AMHS, for secure FAB operation.
- Related Standards:
 - E154, E158, E159 and M80
- Impact to Standards:
 - No change
- Application Note:
 - None.
- Background:
 - Latch mechanism require many components to satisfy requirement.
 - Due to parts distortion and accumulation of parts allowance, latch bar may not be inserted into Carrier shell properly even latch key turned into correct position.
- Approach:
 - Carrier design to avoid staying at intermediate state of door open/close after latch key rotation.
- Note:
 - None.
