SEMI AUX033-0617

450mm PIC Interoperability Report

International 450 mm PIC Task Force
PI&C Global Technical Committee

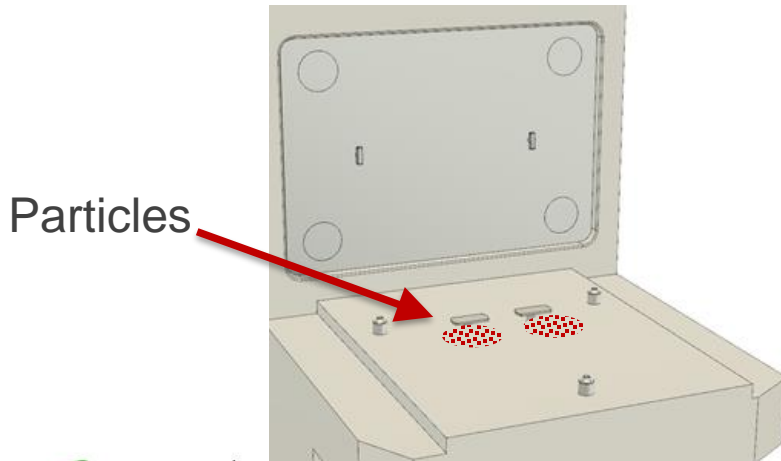
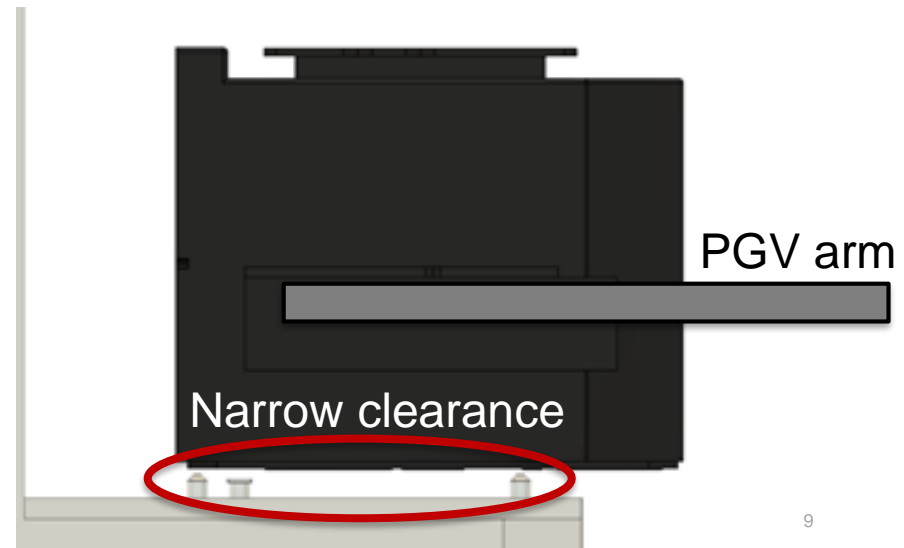
2-A. Kinematic Coupling Functionality

Load Port: Interference Between *Hold-down Devices* and Kinematic Coupling Lead-in Grooves at the time of Carrier Delivery

- Requirement:
 - In order to avoid interference between Carrier and LP features except KC-pins, lead-in function should be considered.
- Related Standards:
 - E154, E158, E159 and M80
- Impact to Standards:
 - No change
- Application Note:
 - None.
- Background:
 - Features that extend above the imaginary plane created by the three kinematic pins have been found to compromise the function of the 10 mm lead-in provided by the kinematic coupling.
 - Critical area – the Carrier clamping mechanism must not collide with the bottom of the Carrier
- Approach:
 - Ensure that no equipment features compromise the lead-in function provided by the kinematic coupling mechanisms.
- Note:
 - The following page presents the interference issue described herein. ¹¹
